Degradation analysis of SiC and AlGaN based photodiodes

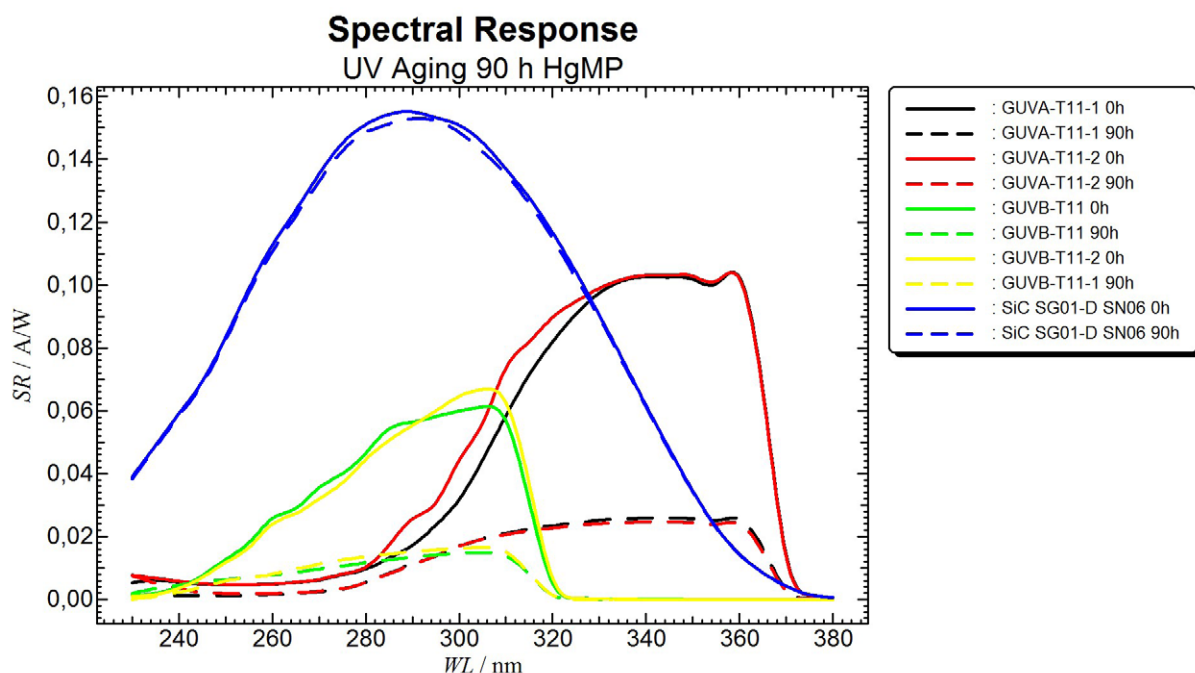
To determine the effect of UV radiation the spectral response (SR) of the photodiodes was measured before (solid lines) and after 90 h (dashed lines) of UV aging. The SiC photodiodes (blue lines) show no measurable degradation. The AlGaN photodiodes (red, black, yellow and green lines) show a degradation between 80 % and 85 %.
